Subj: COMMAND INVESTIGATION INTO THE FACTS AND CIRCUMSTANCES  
SURROUNDING THE FIRE ONBOARD USS BONHOMME RICHARD (LHD 6) ON  
OR ABOUT 12 JULY 2020

# COMMAND INVESTIGATION

**INTO THE FIRE ABOARD  
USS BONHOMME RICHARD (LHD-6)  
12 JULY 2020**

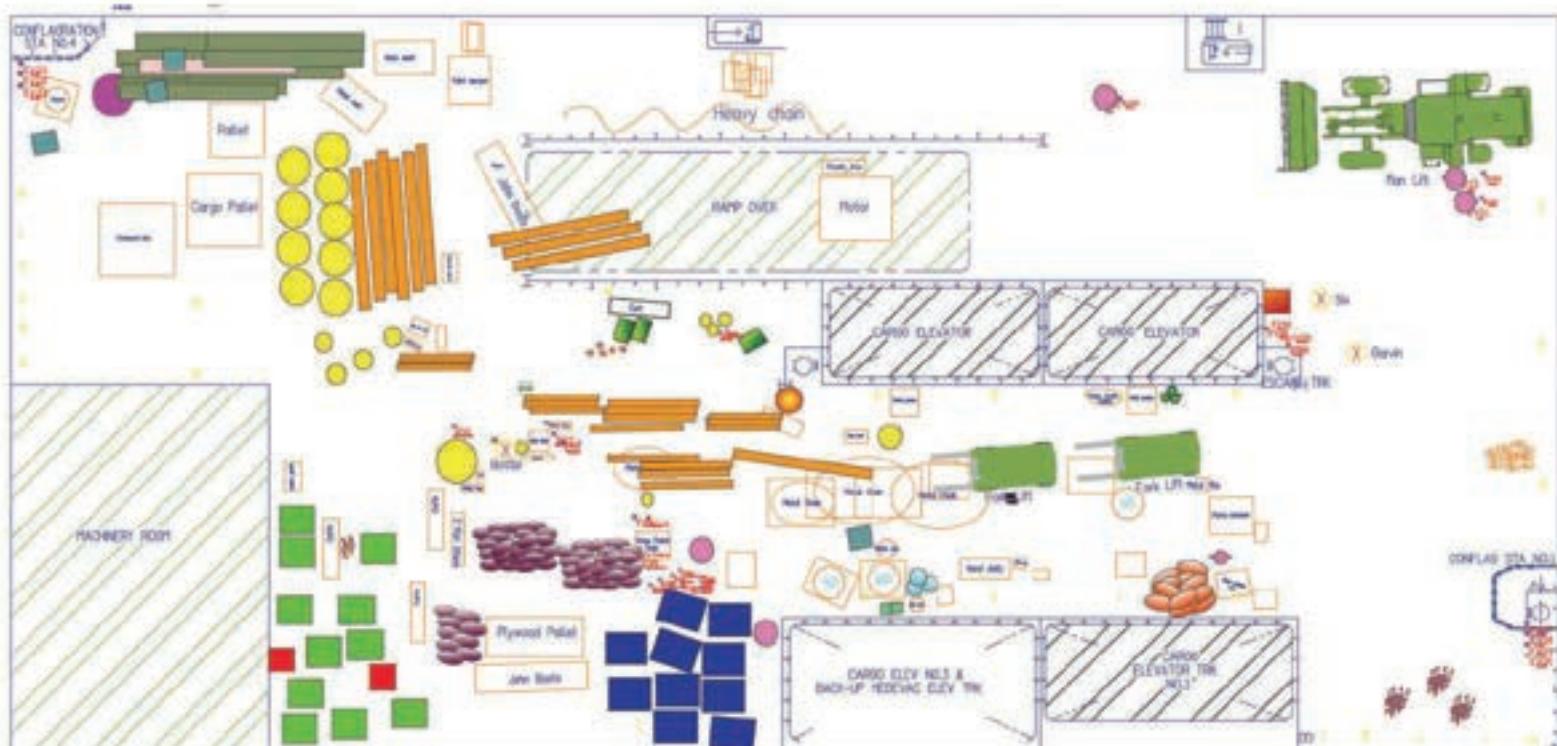
3. ATF determined that once the fire ignited, it spread to the significant amount of combustible material stored within Lower V (See Figure 1), which included dozens of tri-walls filled with gear and equipment and three fueled vehicles (a forklift, a man-lift, and a cargo tractor). [Encl 5]

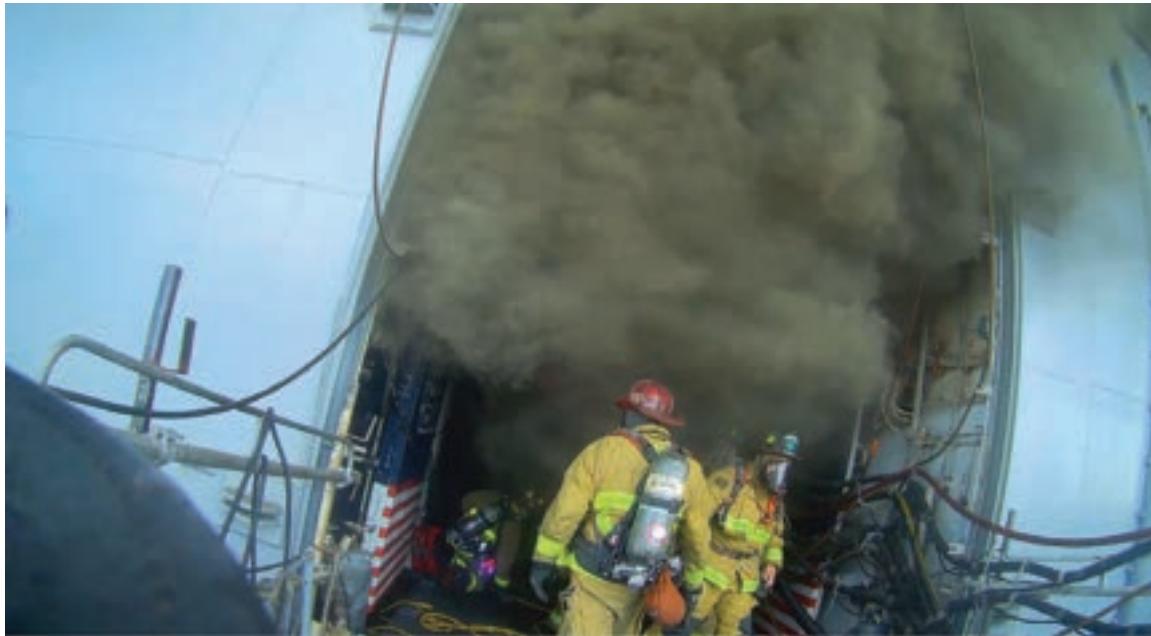
94. As the firefighting efforts continued, SDFD (b) (6) and SDFD (b) (6) observed smoke conditions were deteriorating. The fire transitioned to producing heavy black smoke with a yellow tinge, and multiple SDFD firefighters observed smoke being pulled back into the ship. At approximately 1035, SDFD (b) (6) informed the Assistant Operations Chief, NCFD (b) (6), that firefighters had "lost the space" (referring to Upper V). He then informed the firefighting teams, "This compartment is about to blast, get what you can, get what you can." NCFD (b) (6) radioed his concerns to SDFD (b) (6) and announced his intention to begin withdrawing the attack teams from the ship. Additionally, FEDFIRE (b) (6) received a report from FEDFIRE (b) (6) about the change in smoke conditions. FEDFIRE (b) (6) also noticed the smoke had become very heavy and black. Based on these reports, FEDFIRE (b) (6) also made the call to evacuate and pull all gear off the ship. At 1037, the ICP officially ordered all firefighting teams to evacuate BONHOMME RICHARD. [Encl 126, 141, 148, 164, 181, 229, 230, 239, 240, 241]

Figure 12 shows a screen capture from SDFD Firefighter (b) (6)'s helmet-mounted camera footage, illustrating smoke conditions at approximately 1035.

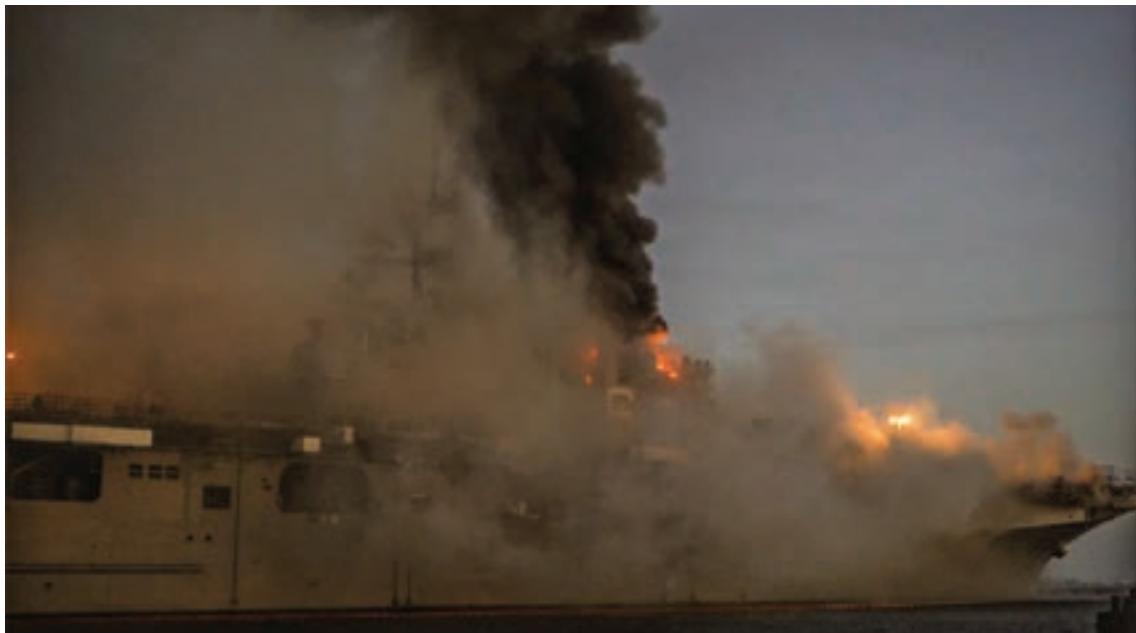
160. At 1954, the fire was observed to be venting out of the superstructure and continued to burn out of control, with an active fire visible from BONHOMME RICHARD's stacks. There were no FEDFIRE personnel or Sailors aboard BONHOMME RICHARD at this time. [Encl 249, 297, 377, 384]

Figure 15 shows BONHOMME RICHARD burning in the evening on 12 July 2020.

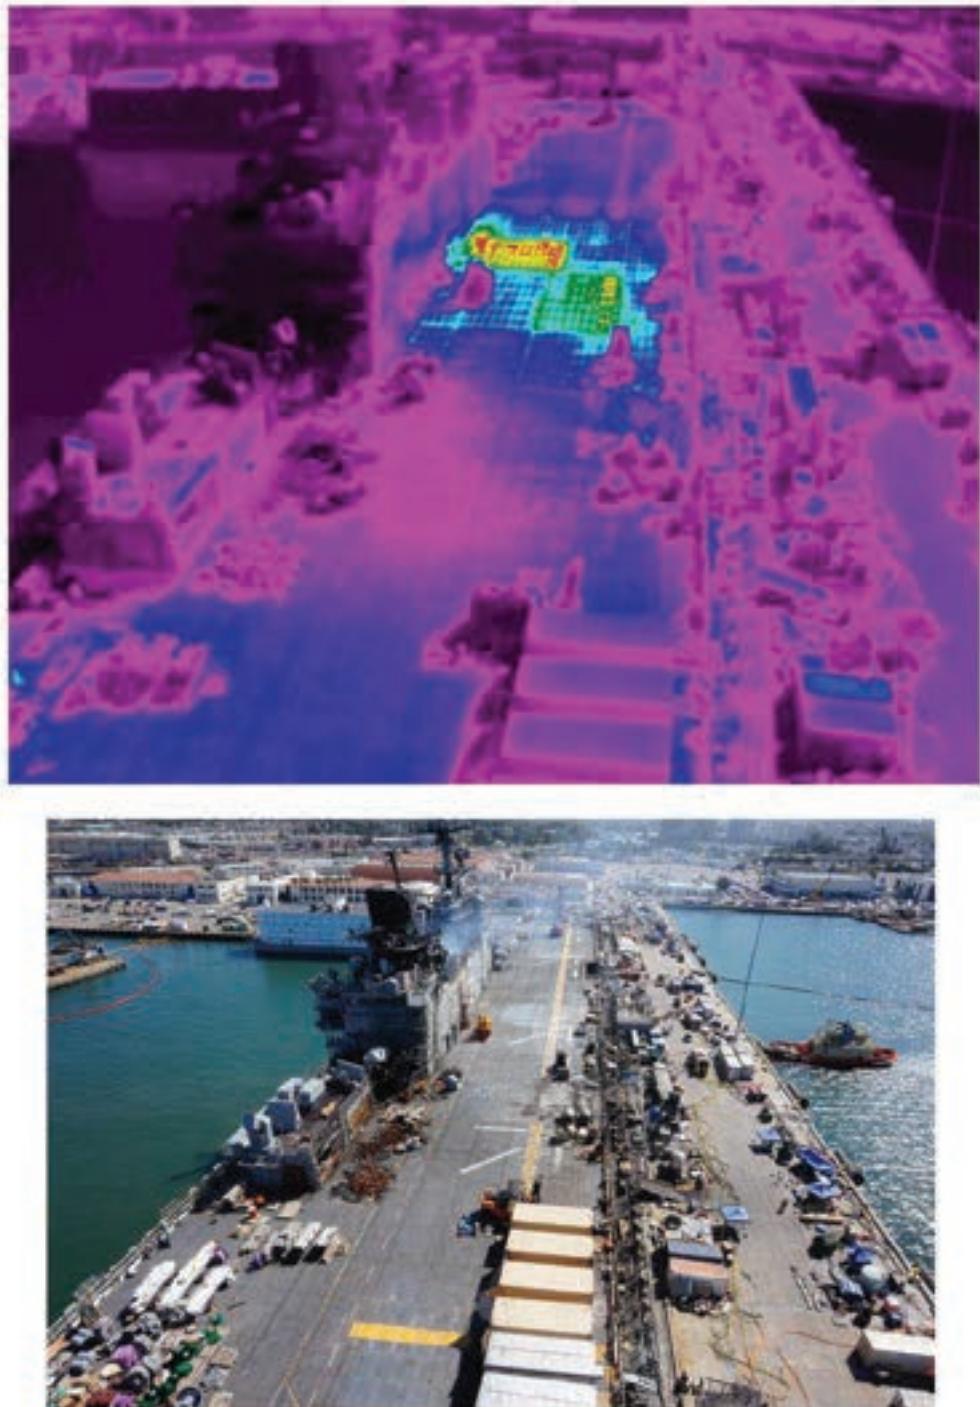
NBSD approval. This drone was subsequently used to identify hot spots for targeted firefighting efforts. US Fire Pump recommended cutting targeted holes in the ship to gain access to compartments with excessive heat or active fire. The first cuts started later that day at approximately 1737. [Encl 34, 141, 249, 314, 392, 394, 407, 409, 410, 411, 412, 413]

Figure 19 show US Fire Pump forward-looking infrared (FLIR) imagery of BONHOMME RICHARD, compared to a standard photograph taken simultaneously by the same drone.

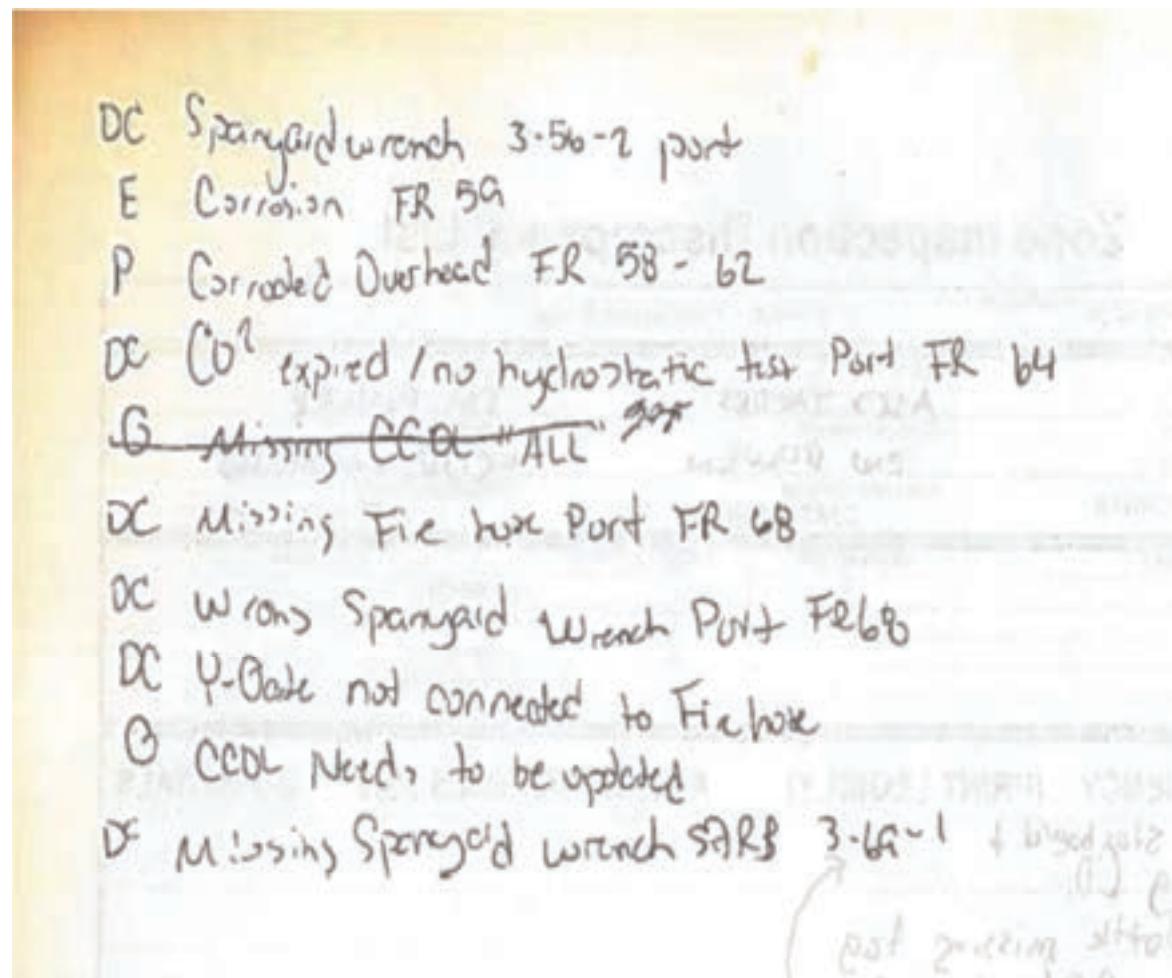
Figure 26 shows the back page of the Zone Inspection Discrepancy List for Upper V assessed on 18 March 2020.

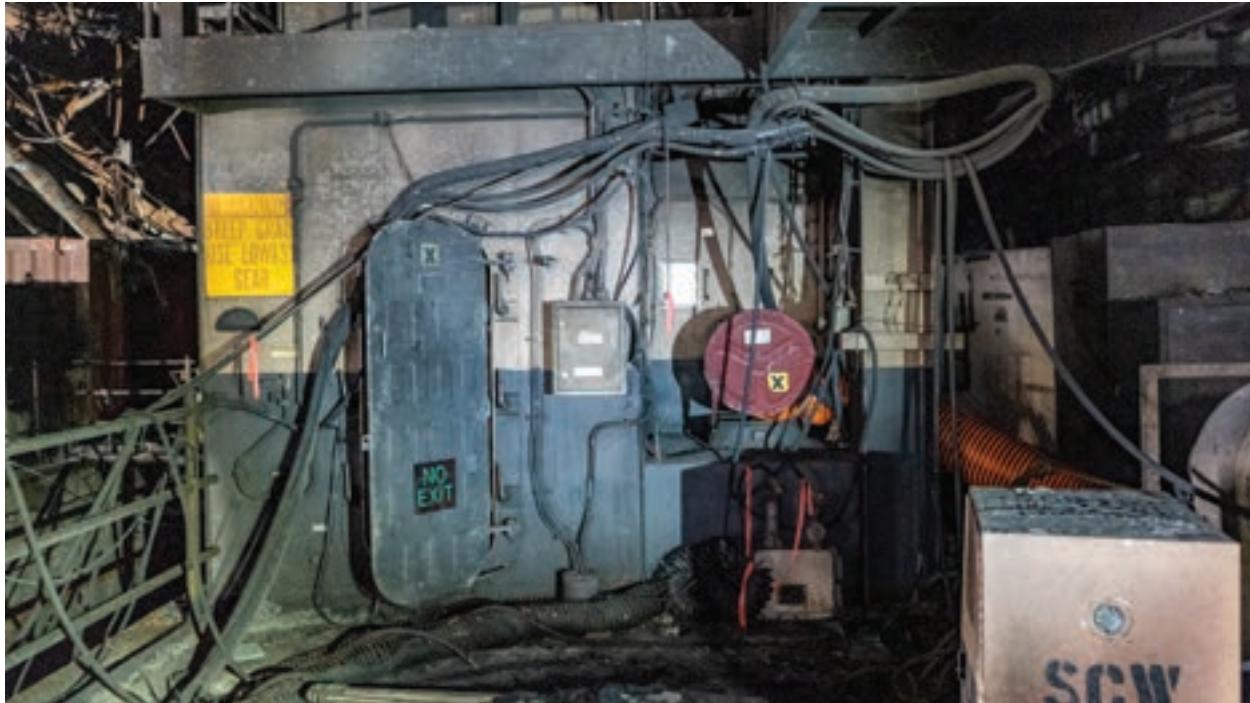
Figure 29, Still photo of AFFF push-buttons for sprinkler groups 15 and 16 serving Lower V (16 on left; 15 on right). These push-buttons are in Upper V amidships. An open hatch obstructs visibility of the push-buttons.

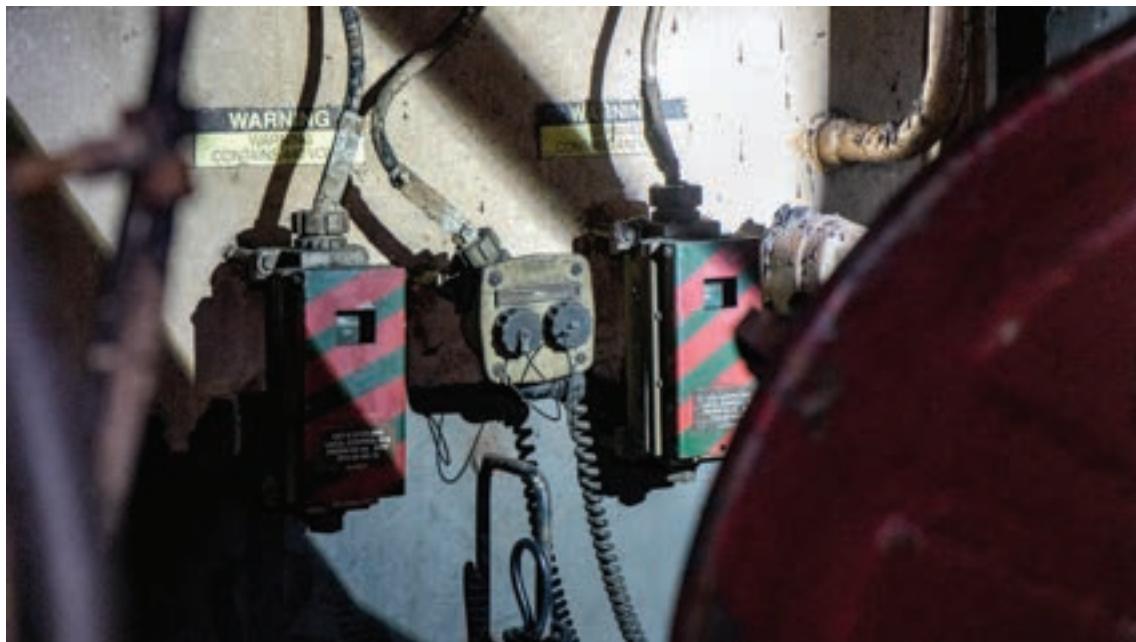
Figure 30, Still photo of AFFF push-buttons for sprinkler groups 15 and 16 serving Lower V with covers closed (16 on left; 15 on right). These push-buttons are in Upper V amidships. The photo shows proximity to open hatch, which obstructs visibility of the push

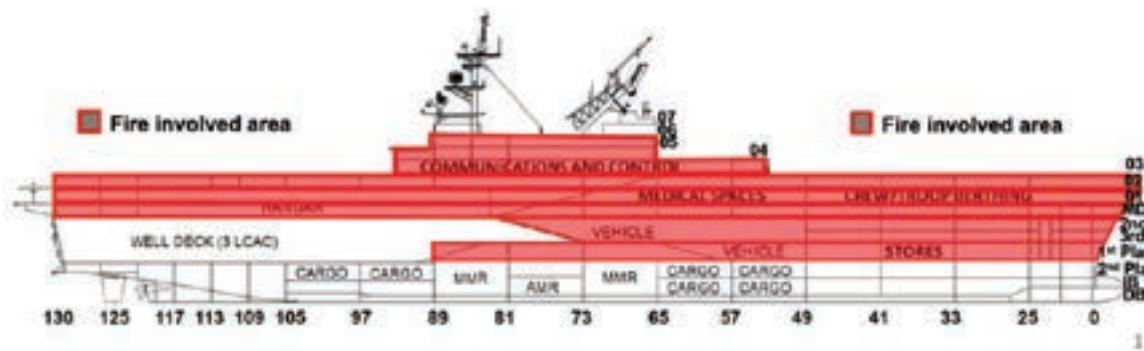
Figure 41 is a MA diagram indicating the fire-involved areas of BONHOMME RICHARD.

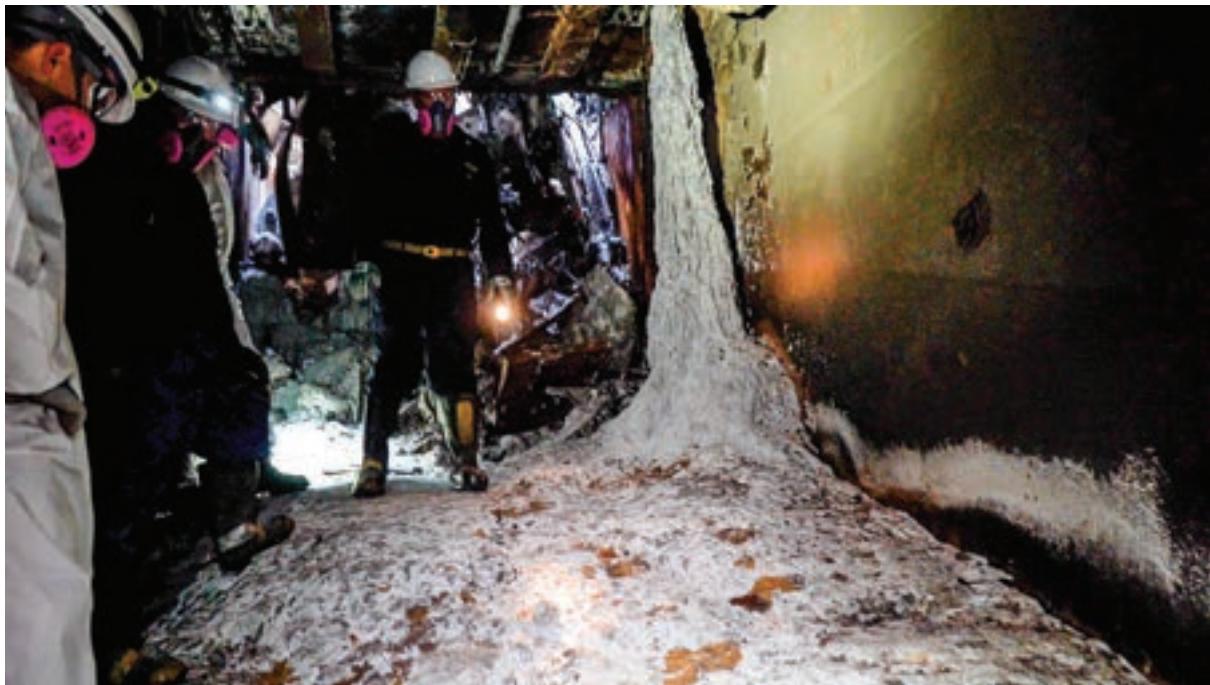
Figure 42 shows investigation team members examining a solidified aluminum flow.

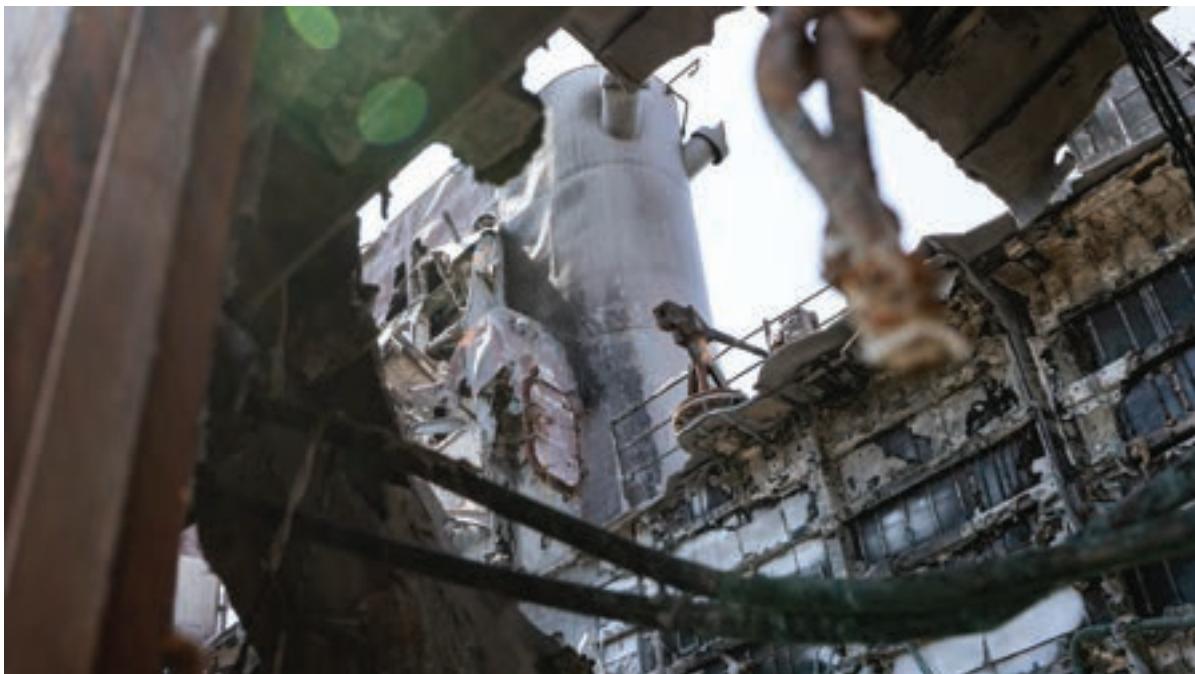
Figure 43 shows the island's interior, illustrating that the overhead has completely burned away.

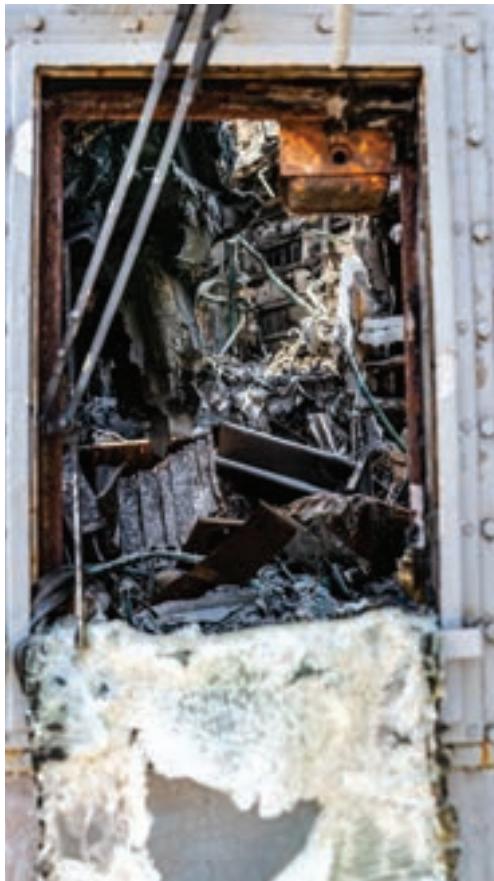
Figure 44 is another photograph of the island's interior.

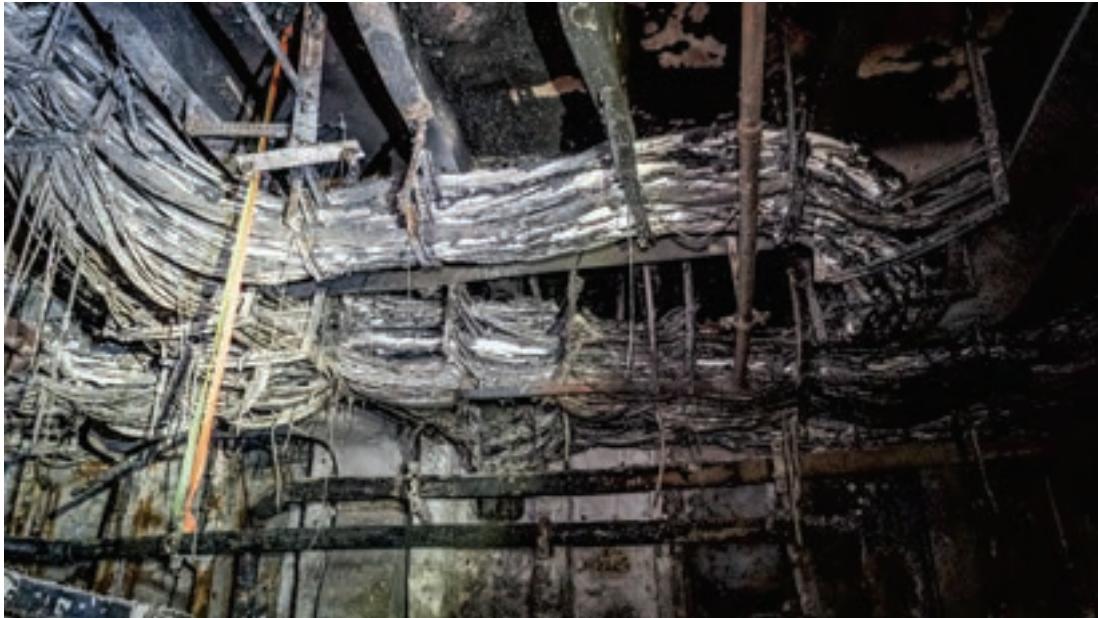
Figure 45 shows burned cableways in the Lower Vehicle Stowage Area (Lower V).

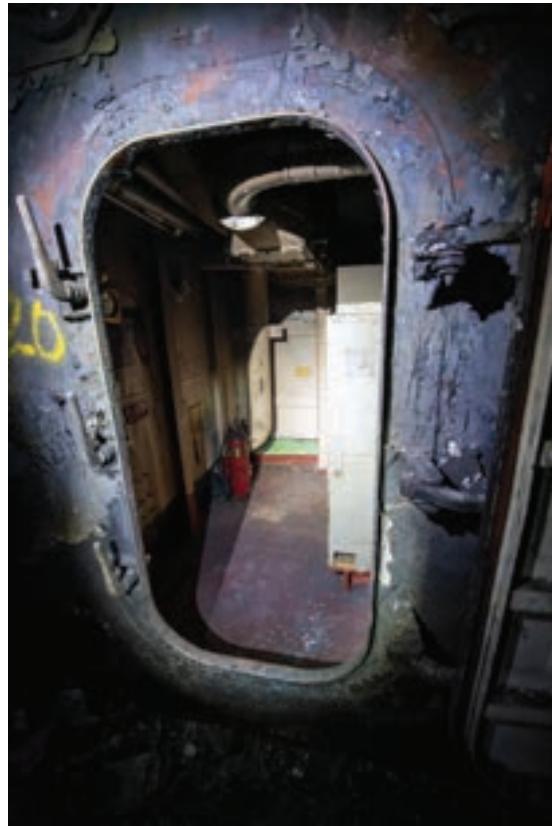
Figure 47 shows two compartments separated by a closed hatch. One compartment was severely damaged, while the adjacent compartment suffered minor damage.
