Subj: COMMAND INVESTIGATION INTO THE FACTS AND CIRCUMSTANCES  
SURROUNDING THE FIRE ONBOARD USS BONHOMME RICHARD (LHD 6) ON  
OR ABOUT 12 JULY 2020

# COMMAND INVESTIGATION

**INTO THE FIRE ABOARD  
USS BONHOMME RICHARD (LHD-6)  
12 JULY 2020**

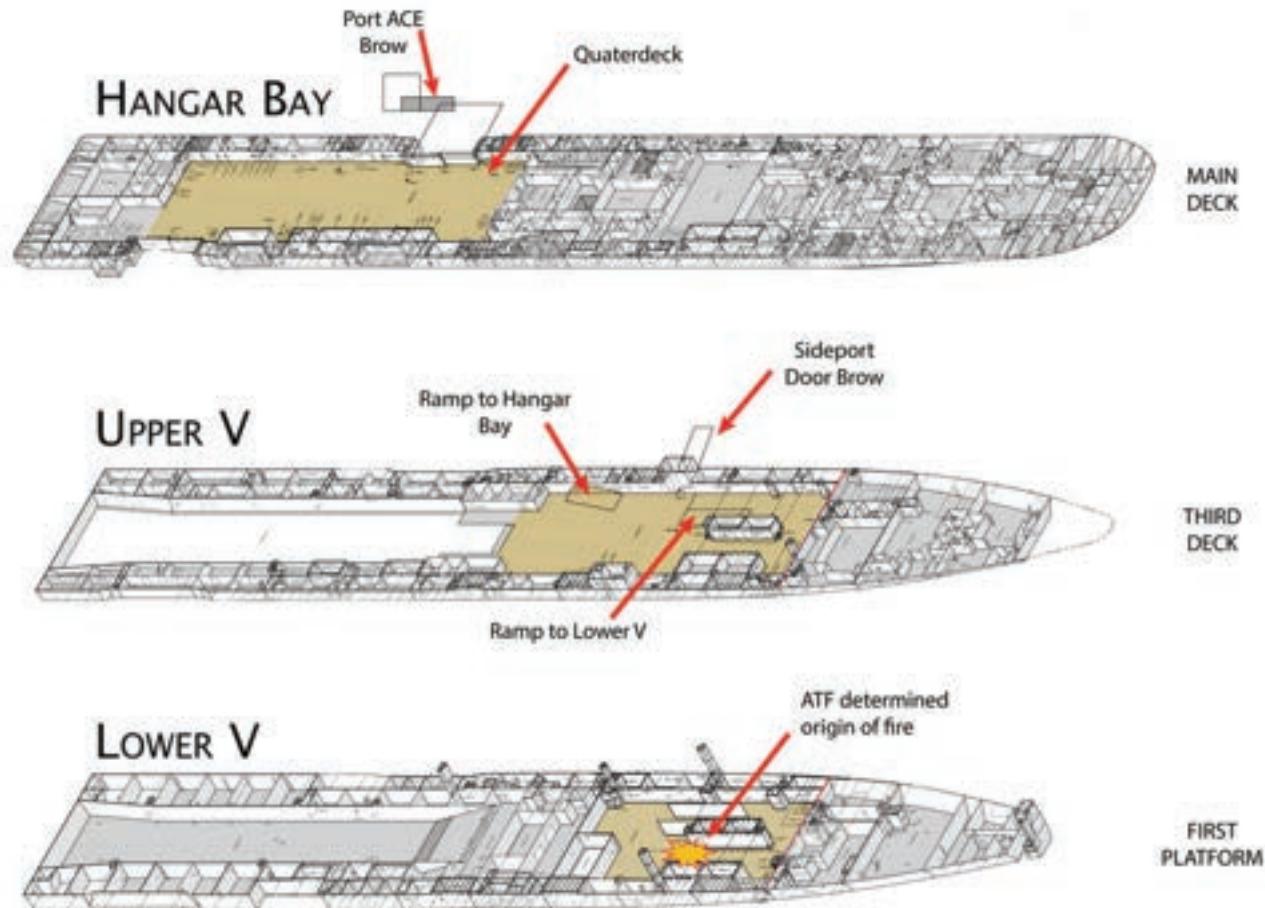
Figure 2 depicts various BONHOMME RICHARD decks and compartments.

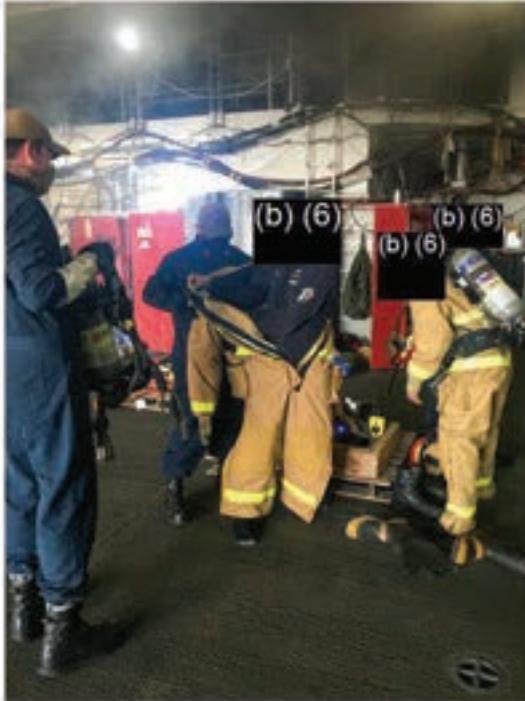
25. Following the 1MC announcement from the Quarterdeck, BONHOMME RICHARD Sailors began assembling in the Hangar and dressing out in SCBAs and Firefighting Ensembles (FFEs). Multiple Sailors, including several Chief Petty Officers (CPO), reported they did not dress out in FFEs because they were wearing the Type III Navy Working Uniform (NWU), rather than coveralls. The choice not to dress out was at least partially based on an assumption that it is not

Figure 3 captures BONHOMME RICHARD Sailors dressing out in the Hangar.

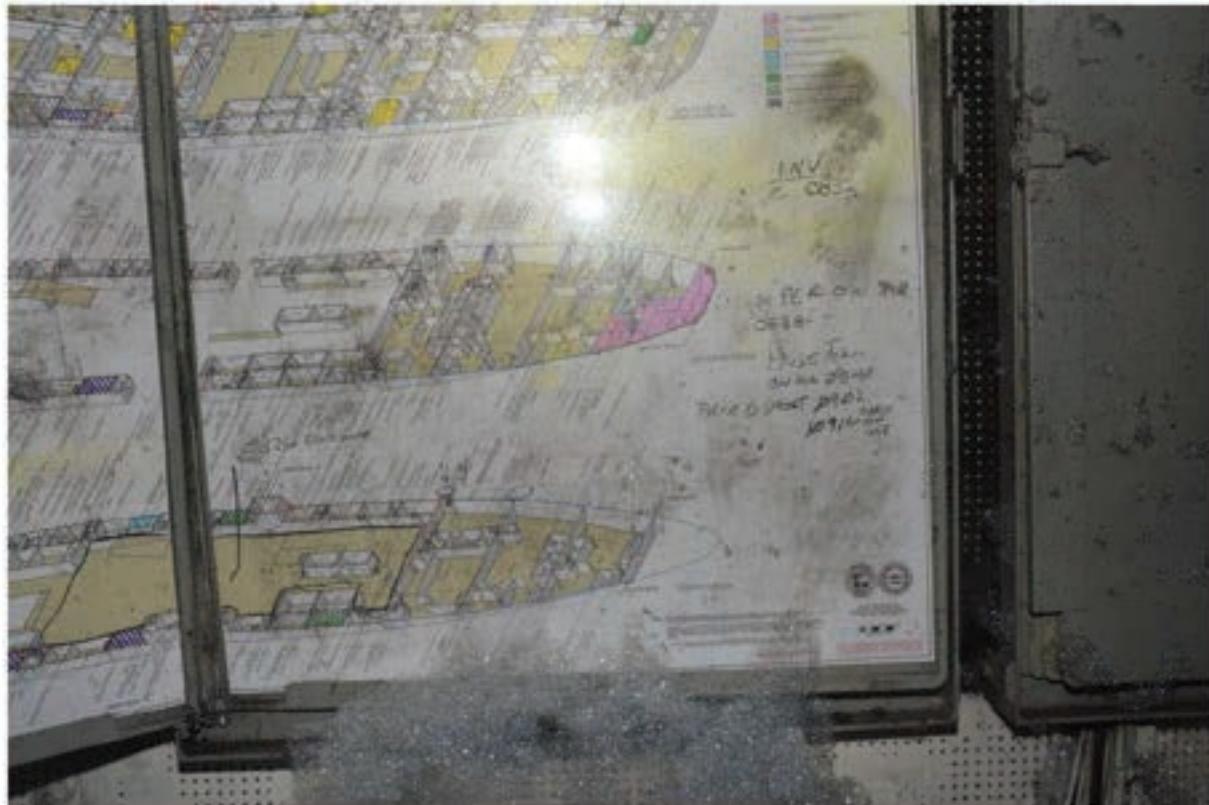
35. DC Central DC plates indicate that at 0838, a four-man team went donned SCBAs and went on air. At 0840, the DC Central DC plates indicate that a hose team went on air. In handwritten notes, the EDO also logged a six-man team on air at 0904. (See Figure 4, which depicts the BONHOMME RICHARD DC plates in DC Central). [Encl 69]

Figure 4 depicts the BONHOMME RICHARD DC plates in DC Central.

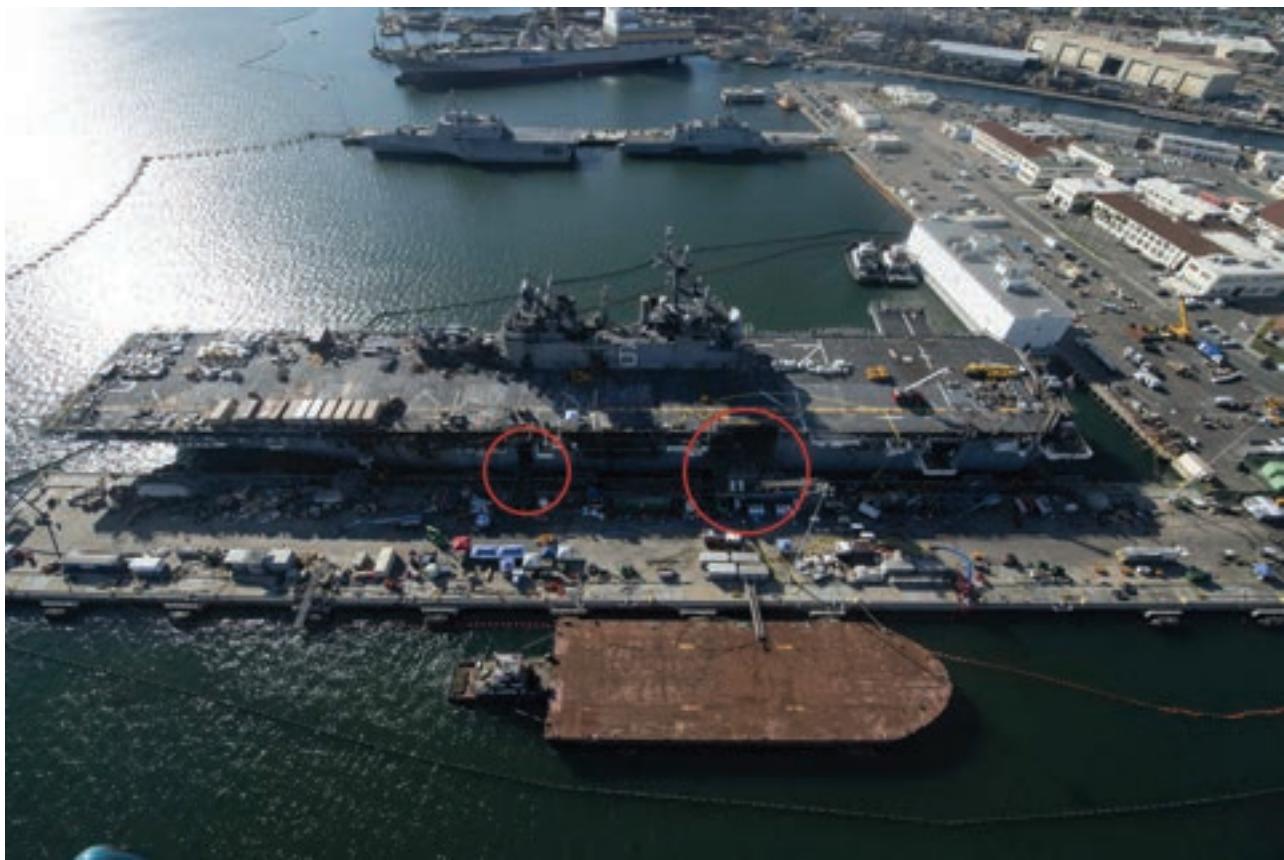
Figure 5 is a photograph of BONHOMME RICHARD with the sideport door/port ACE identified.

49. FEDFIRE proceeded to establish its attack via the port ACE (See Figure 5 above) and commenced running hoses from its engines on the pier up to the port ACE. With no installed firemain system on Pier 2 (or any other NBSD pier), FEDFIRE Engine 161 connected to the potable water riser, which was supplying water to FITZGERALD located on Pier 2. Once established in the Hangar, FEDFIRE ran hoses through the forward portion of the Hangar, down the Upper V ramp, through Upper V, and down the ramp to Lower V. Engine 161, led by FEDFIRE (b) (6) [REDACTED], was the first team to lay a hose line down to Lower V. His team consisted of four FEDFIRE firefighters and (b) (6) [REDACTED]. FEDFIRE Engine 161 laid 200 feet of hose from the Quarterdeck, across the Hangar, down the Upper V ramp, and across Lower V. They then had to attach an additional 100 feet down the ramp. After laying this hose, FEDFIRE Engine 161 was not able to combat the fire because a team member received a “low air” alarm on his SCBA. FEDFIRE (b) (6) [REDACTED]’s team egressed at approximately 0904. [Encl 44, 126, 140, 148, 149, 151, 152, 153, 154, 155]

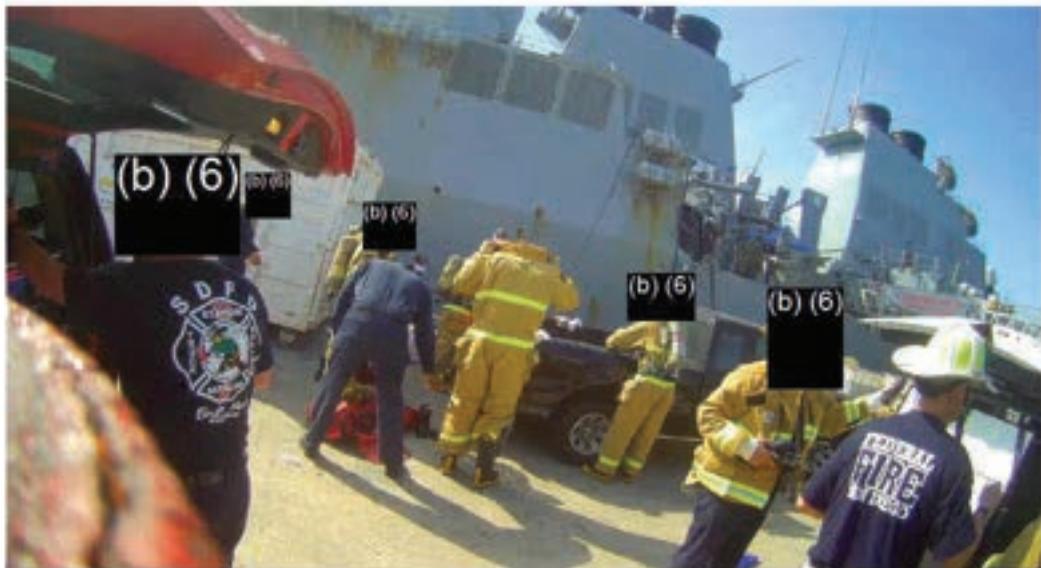
Figure 6 is a screen capture from SDFD (b) (6)'s helmet-mounted camera footage. The image shows the ICP (FEDFIRE and SDFD command vehicles with tailgates up) at approximately 0910.

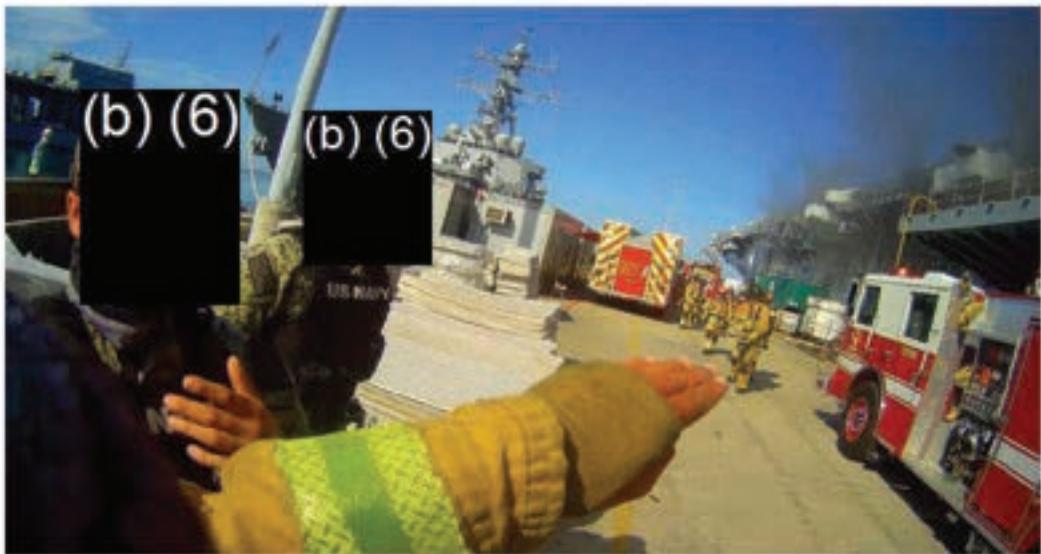
Figure 7 is a screen capture from SDFD (b) (6)'s helmet-mounted camera footage. At approximately 0908, SDFD (b) (6) stopped Sailors to seek information about the fire.

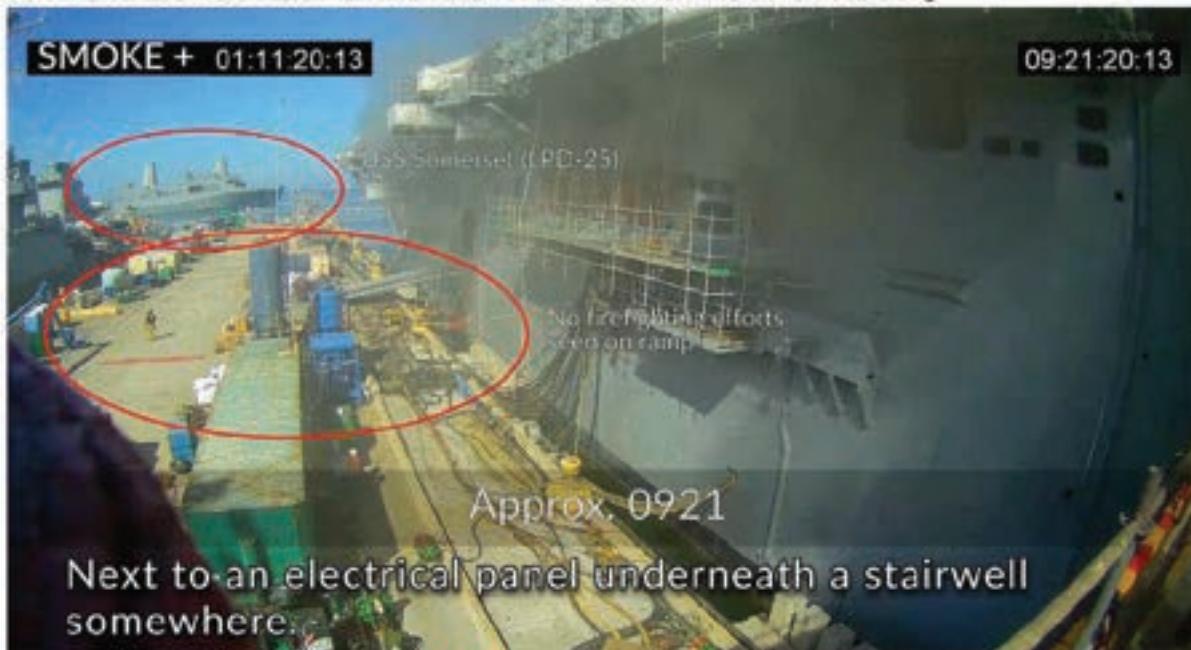
Figure 8 is a screen capture from SDFD (b) (6)'s helmet-mounted camera footage (subtitles and other text added by the investigation team). SDFD (b) (6) was speaking about the location of the fire. No personnel are visible by the sideport door.

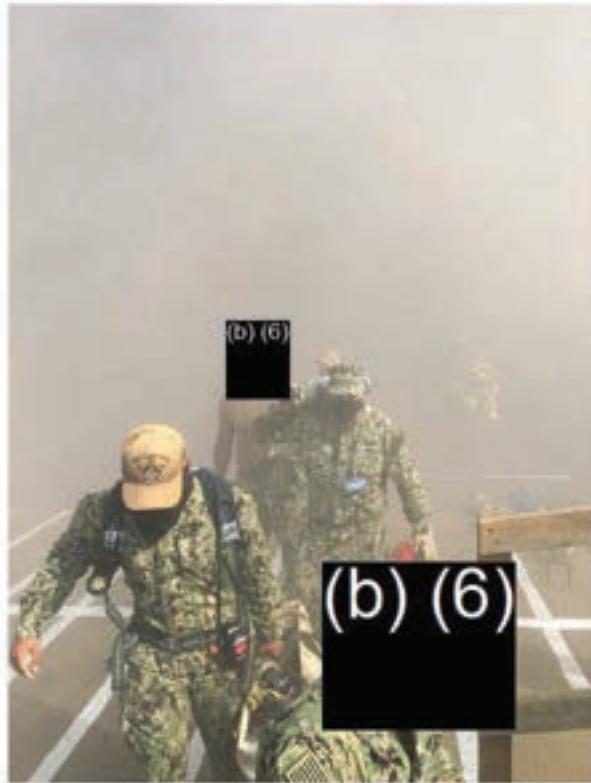
Figure 9 shows Sailors evacuating the BONHOMME RICHARD Hangar.

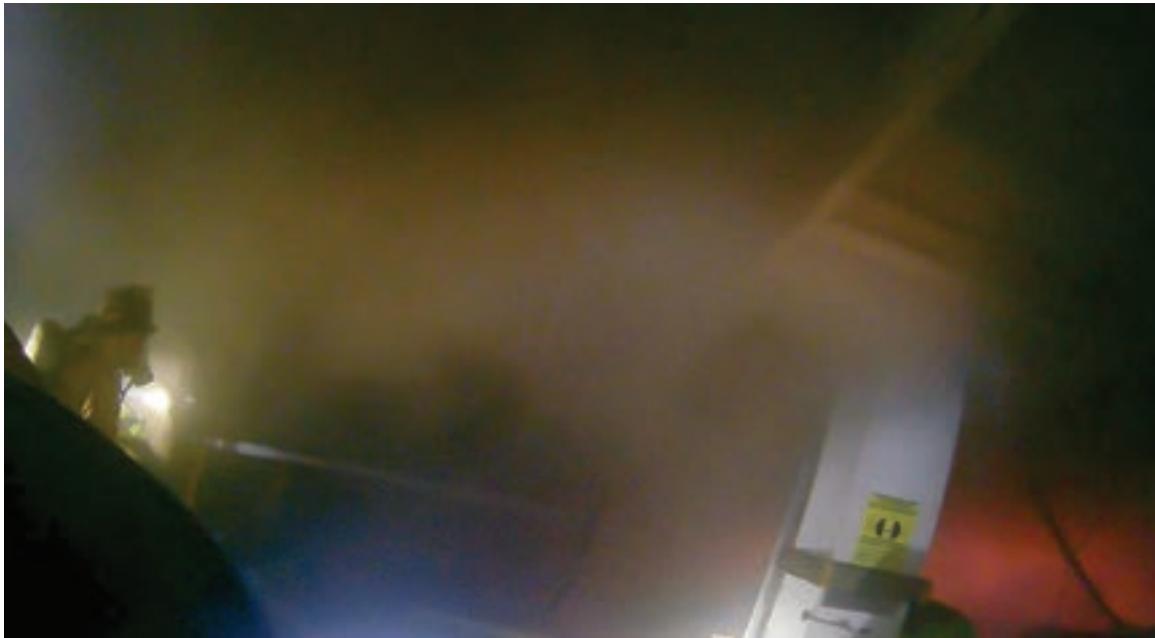
Figure 11 shows a screen capture from SDFD Firefighter (b) (6)'s helmet-mounted camera footage. This image captures the first time agent was applied to fire on 12 July 2020, as SDFD teams applied firefighting water to the radiant fire in Upper V at approximately 0951.

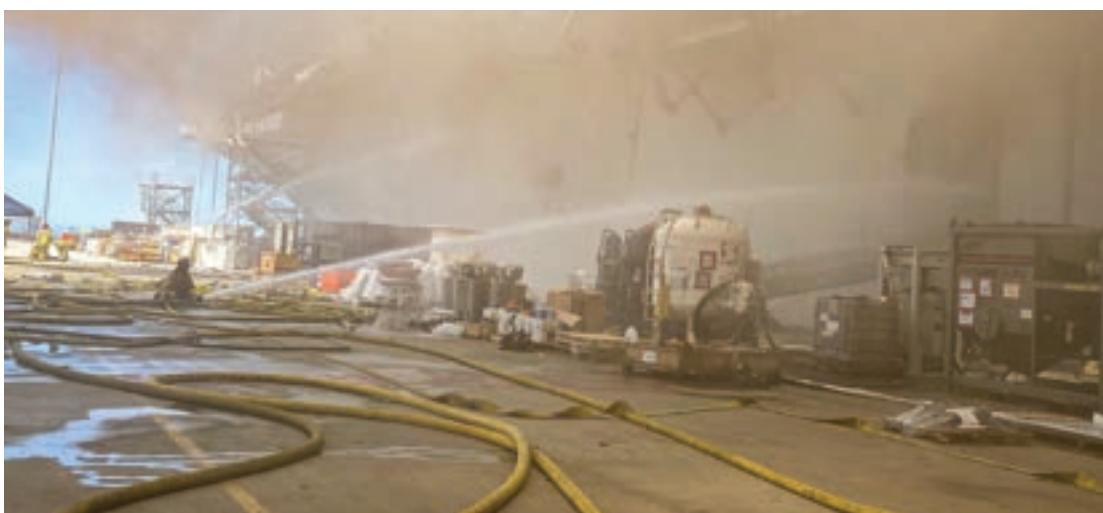
Figure 13 shows firefighting monitors spraying water from the pier on 12 July 2020.

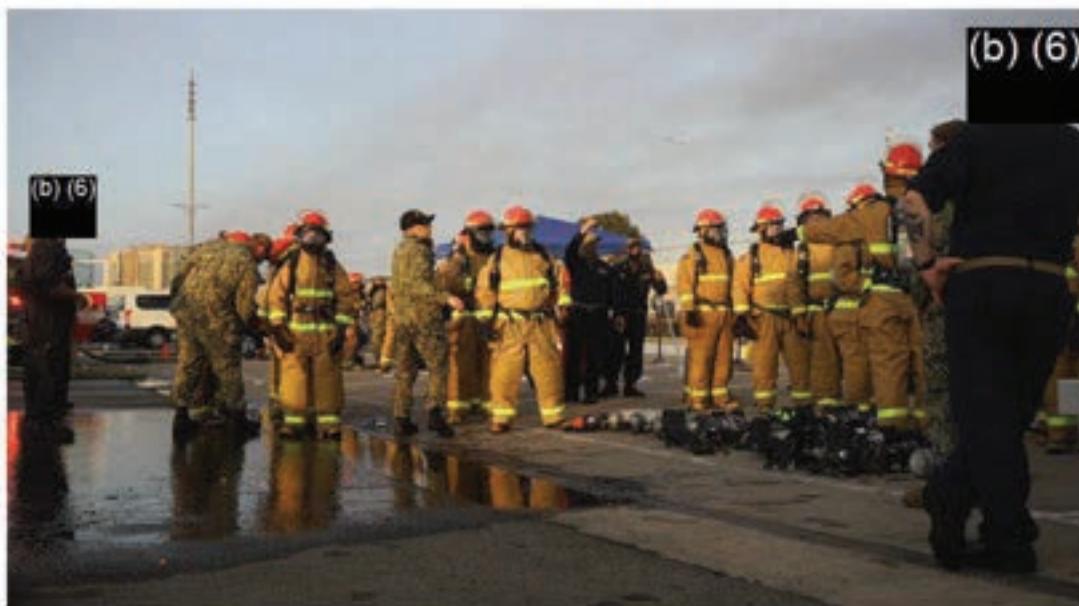
Figure 14 shows BONHOMME RICHARD Sailors organizing into fire teams.

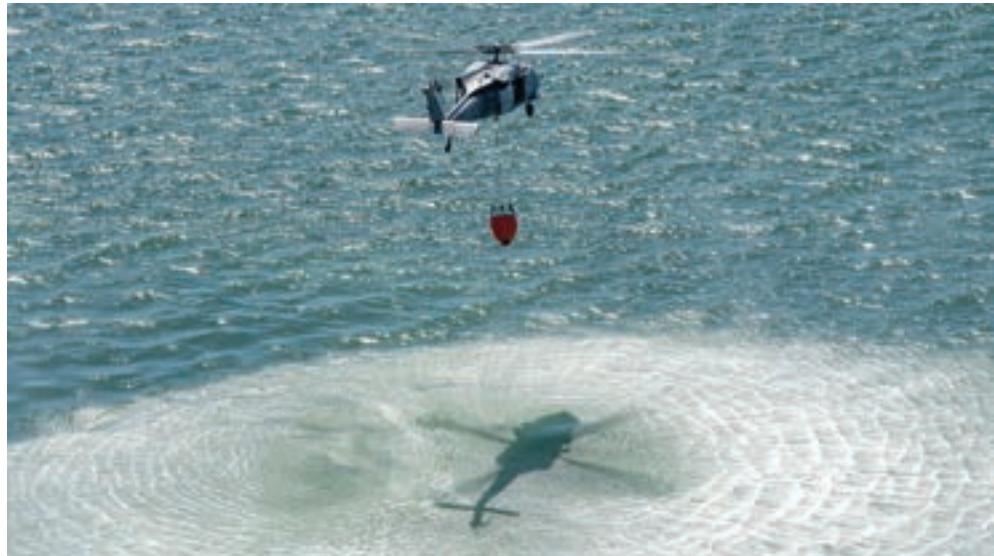
172. From 12 July 2020 until 15 July 2020, 1,649 water drops were conducted, deploying 545,076 gallons of water. (See Figures 16 and 17). After 12 July 2020, the SCORE detachment was augmented by additional aircrews from HSC-3. Various Navy, FEDFIRE, and contract firefighting personnel disagreed about the overall effectiveness of the water drops. [Encl 188, 308, 391, 393, 394, 395]

Figure 16 shows a SH-60 helicopter picking up water to conduct water drops on BONHOMME RICHARD.

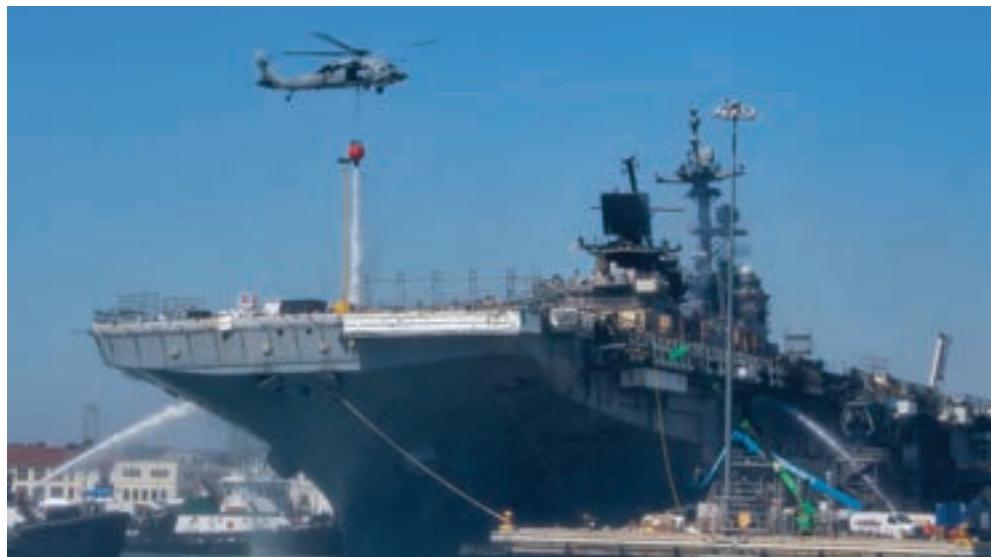
Figure 17 shows a helicopter conducting a water drop on BONHOMME RICHARD.

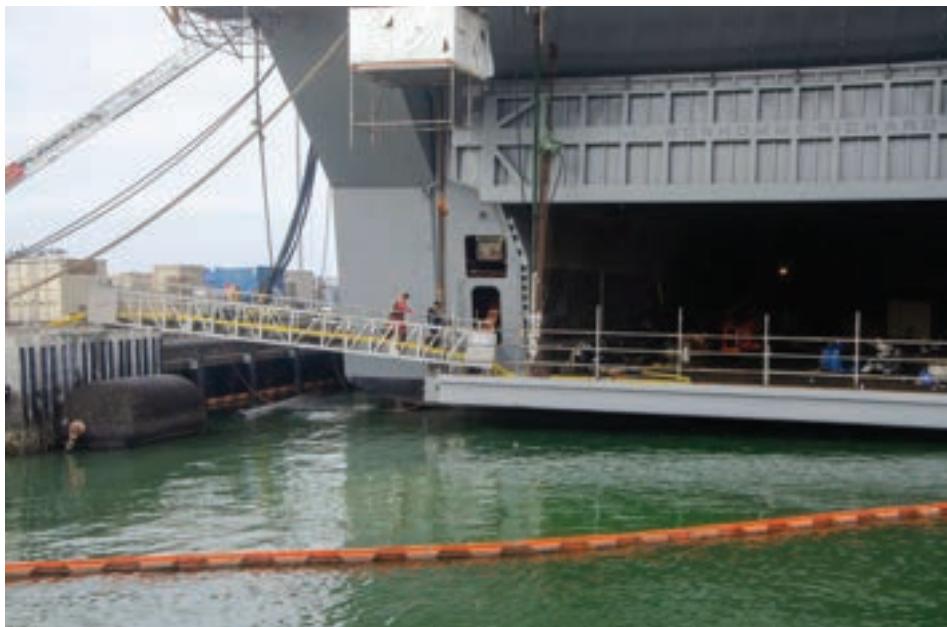
175. At approximately 0211, 13 July 2020 a NAVFAC crane, organized by (b) (6) , landed a brow on the stern gate, enabling a 20-man hose team to enter and relieve the 5-man team. (See Figure 18). This team continued the fire attack by advancing forward through the Well Deck toward Upper V. [Encl 72, 179, 187, 249, 313, 385, 396, 397, 398]

Figure 18 shows the stern gate brow, which was landed at approximately 0211 on 13 July 2020.

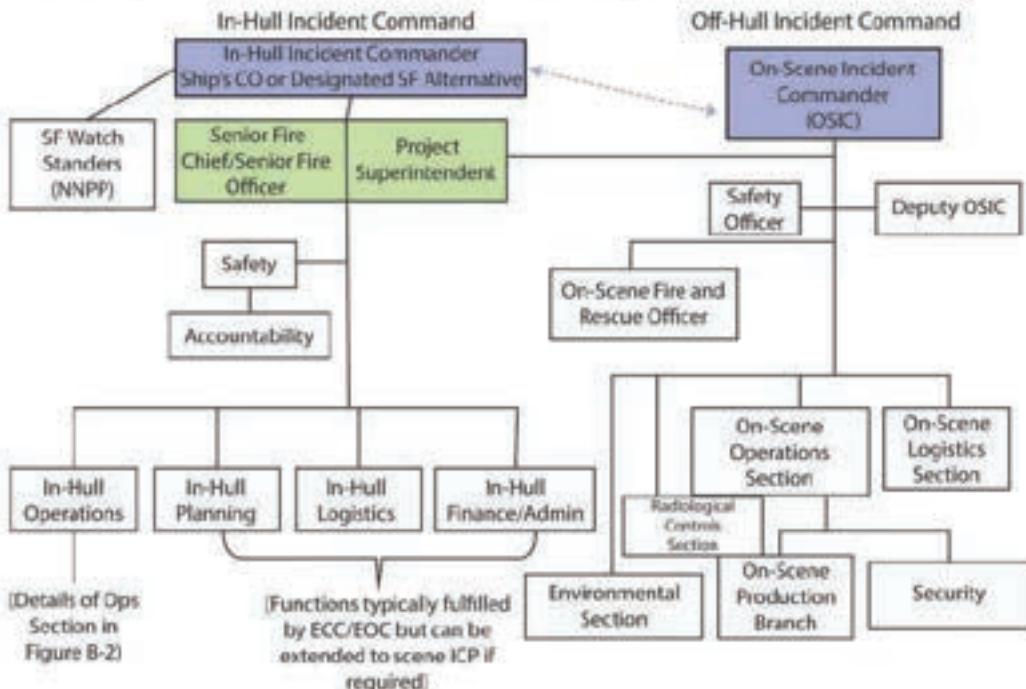
Figure 22, Incident Management Structure per the 8010 Manual.

241. Per the 8010 Manual, the in-hull IC, with the support of the F&ES Chief/Senior F&ES Officer, is responsible for the safety, accountability, and well-being of the integrated F&ES, SF, and mutual aid firefighting resources. The in-hull IC also directs “off-hull” actions “until establish[ment] of the on-scene incident command,” which is led by the Ship Repair and/or Construction Activity (SRCA). This “off-hull incident command” construct is not discussed in OPNAVINST 3440.18.

1199. Neither the SWRMC Fire Response Plan (SWRMCINST 5100.11C dated 31 January 2020) nor MARMC Fire Response Plan (MARMCINST 11320.1D dated 22 July 20) reference OPNAVINST 3440.18. Additionally, the 8010 Manual does not incorporate OPNAVINST 3440.18, resulting in three distinct command and control structures. (See Figures 22, 23, and 48). [Encl 1122, 1123]

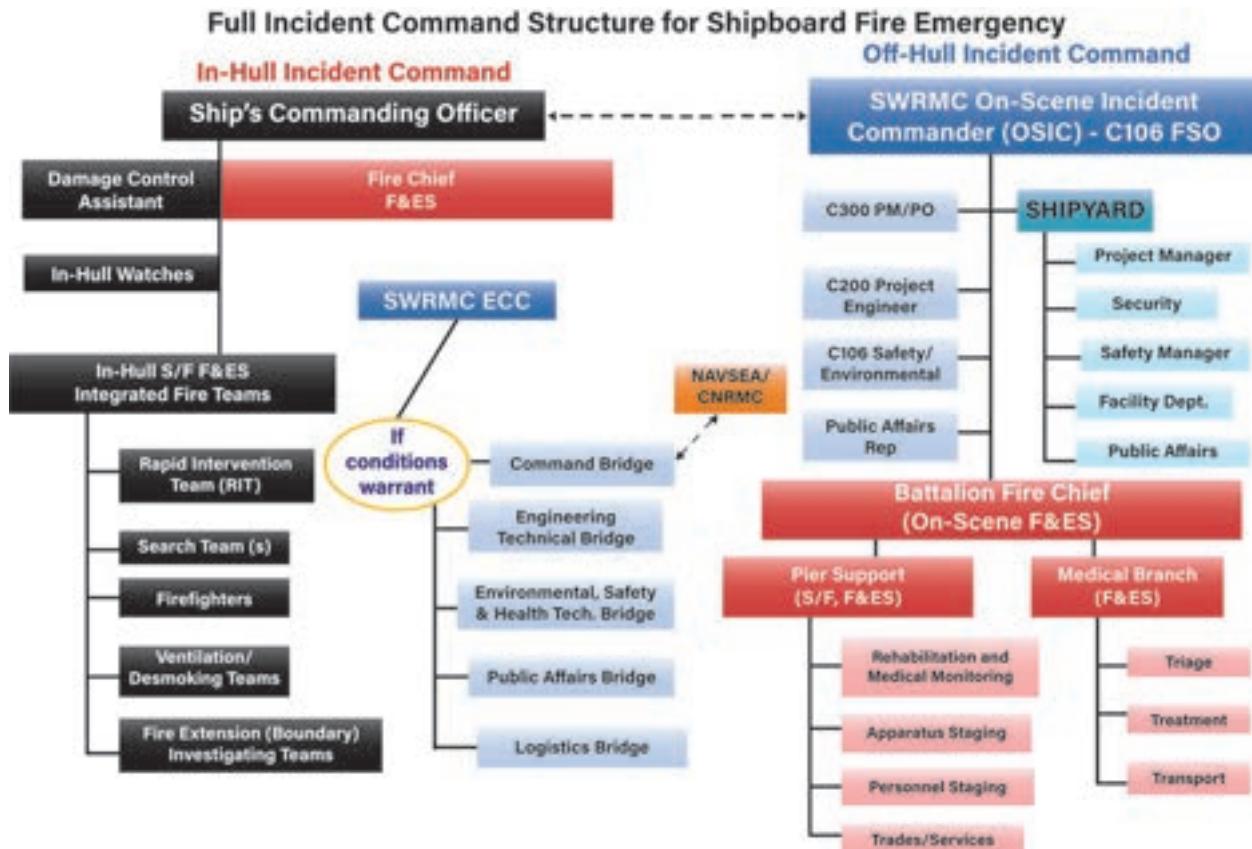
Figure 23, Full Incident Command Structure for Shipboard Fire Emergency per SWRMCINST 5100.11C (Fire Response Plan).

242. SWRMC's Fire Response Plan (FRP) further defines the incident command structure for a shipboard fire emergency while a ship is undergoing an availability. (See Figure 23 below). The FRP also defines the role of SWRMC's Emergency Command Center (ECC) and provides for an "off-hull" incident command, as discussed in the 8010 Manual, but in contrast to OPNAVINST 3440.18, which does not describe an off-hull incident command. [Encl 474]

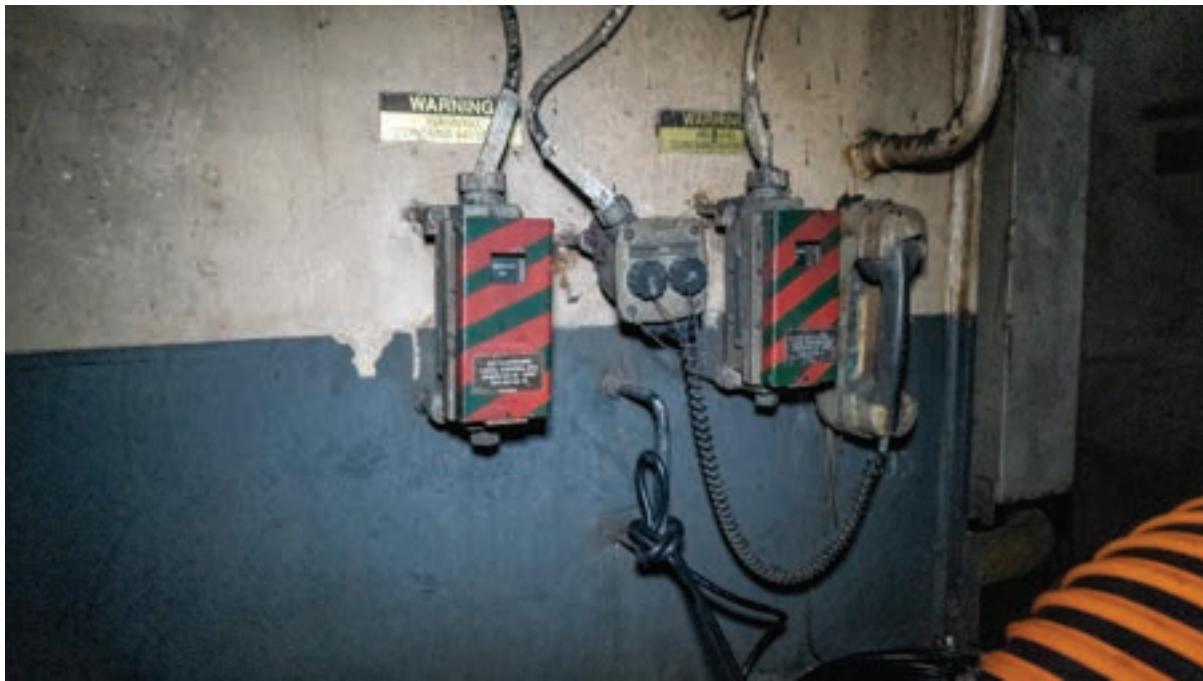
Figure 31, Still photo of AFFF push-buttons for sprinkler groups 15 and 16 serving Lower V with covers closed (16 on left; 15 on right). These push-buttons are in Upper V amidships.

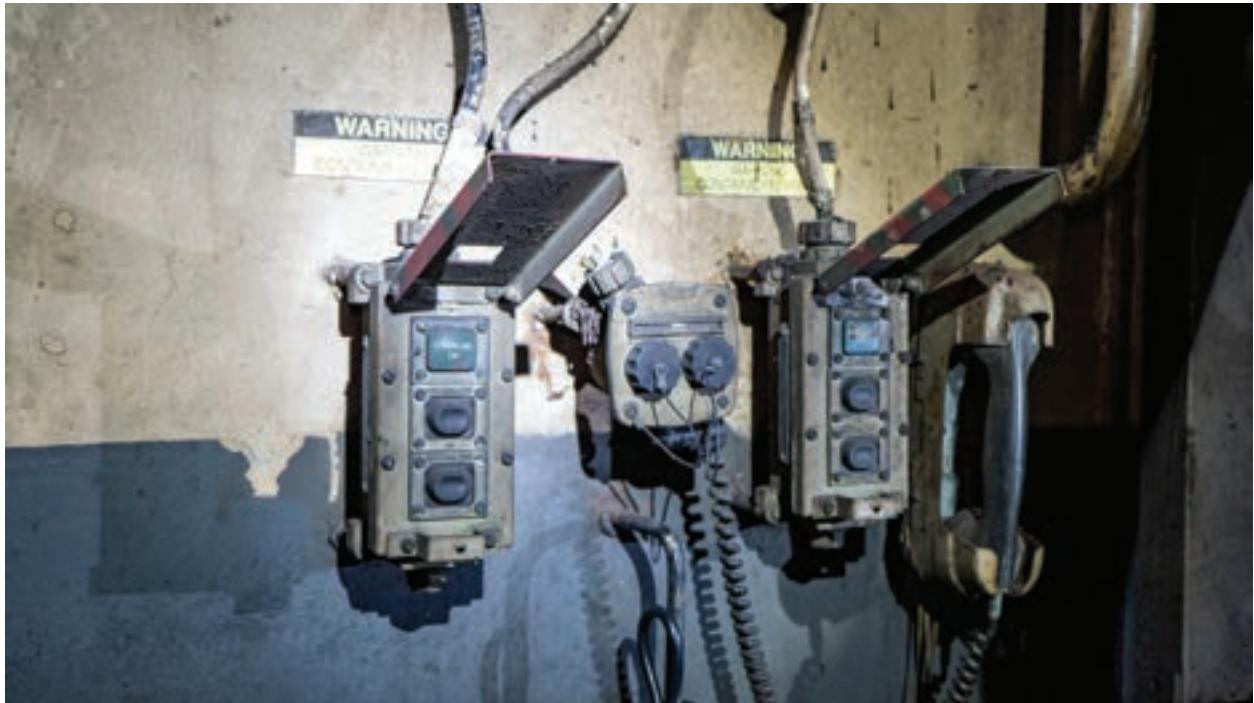
Figure 32, Still photo of AFFF push-buttons for sprinkler groups 15 and 16 serving Lower V with covers open (16 on left; 15 on right). These push-buttons are in Upper V amidships.

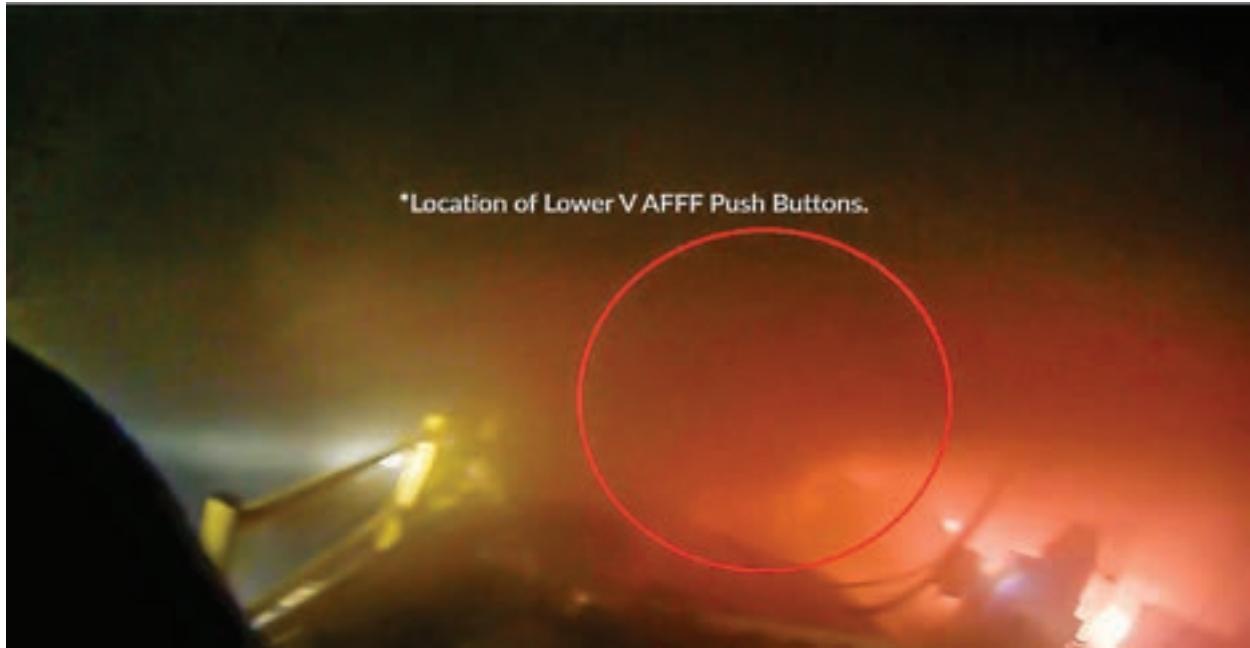
Figure 33, Still photo captured from GoPro video provided by San Diego Fire Department (SDFD) showing the location of AFFF push-buttons on 12 July 2020 after SDFD made entry into the vehicle stowage area via the sideport.

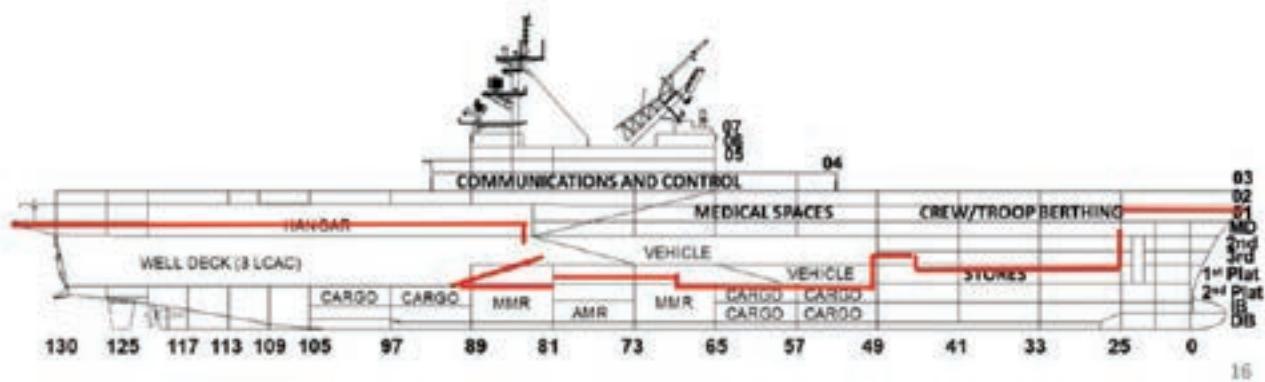
1046. To aid in repair calculations, the MA established an approximate “cut-line,” above which virtually no compartment is salvageable. The MA concluded that restoration above the cut-line would entail the removal and replacement of entire decks, compartments, and all associated contents and equipment. Major spaces above the cut-line include: the island structure, all 02-level compartments for the entire length of the ship, all 01-level compartments from Frame 25 to the stern, all compartments on the Main Deck from Frames 25 to 89. Key spaces below the cut-line that still require total replacement include Damage Control (DC) Central (5-79-0-C, Ship’s Laundry (4-73-0-Q), Upper Vehicle Stowage Area (Upper V) (3-49-0-A) and Lower V (4-49-0-A). [Encl 731]

Figure 46 shows the NAVSEA “cut-line.”

1047. Below the cut-line, the MA concluded that most compartments are either intact or could be repaired via standard ship repair processes. Major spaces below the cut-line include: 1 Main Machinery Room (MMR) (6-65-0-E), 2 MMR (6-81-0-E), Auxiliary Machinery Room (AMR) (6-73-0-E), Lower Cargo Ammunition Magazines (6-49-0-M, 6-57-0-M), Aft Steering (7-121-2-

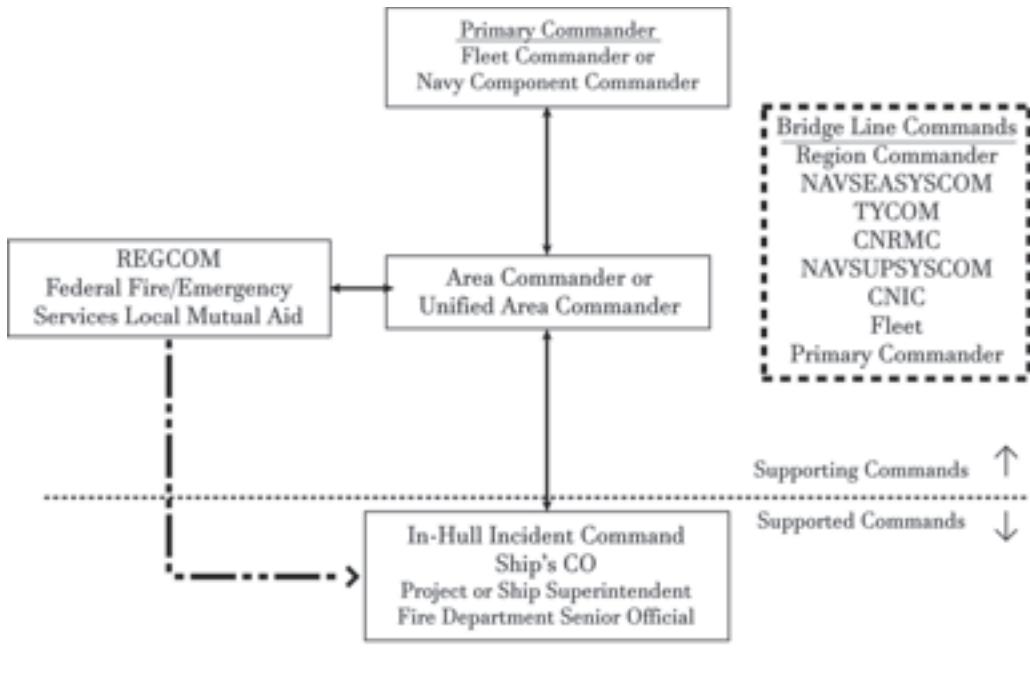
Figure 1 - Chain of Command

1195. On 13 November 2018, six years after the MIAMI Fire Review Panel recommended issuance of the directive, OPNAVINST 3440.18 was published. Consistent with the MIAMI Fire Review Panel recommendation, OPNAVINST 3440.18 designates Primary Commands, who have a responsibility to further designate area commands and establish their required responsibilities. For ports in the U.S. Indo-Pacific Command (like BONHOMME RICHARD on 12 July 2020) and the U.S. Northern Command Areas of Responsibility (AOR), primary command responsibility rests with PACFLT. [Encl 1020]
