Major Fires Review

Executive Summary

Commander, U.S. Fleet Forces Command

Commander, U.S. Pacific Fleet

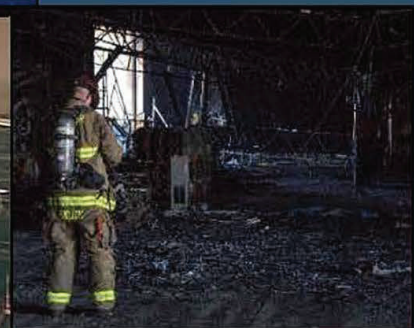
Bottom right: Federal firefighters assess damage in the hangar bay aboard the amphibious assault ship USS Bonhomme Richard (LHD 6) on July 15, 2020. (U.S. Navy photo)
